# Facilities Assessment Presentation

March 6, 2012

Provide an objective analysis of the physical needs of 26 branches of the Cleveland Public Library categorized into Priorities

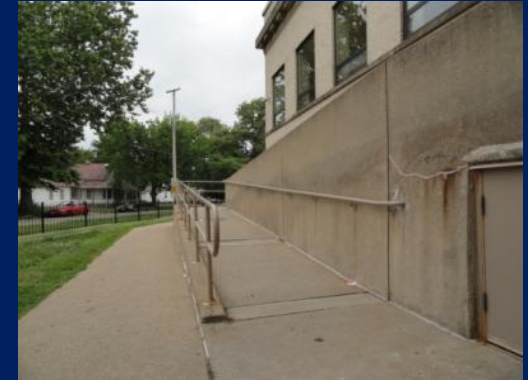
Need ADA compliant entry ramps:

Lorain Branch

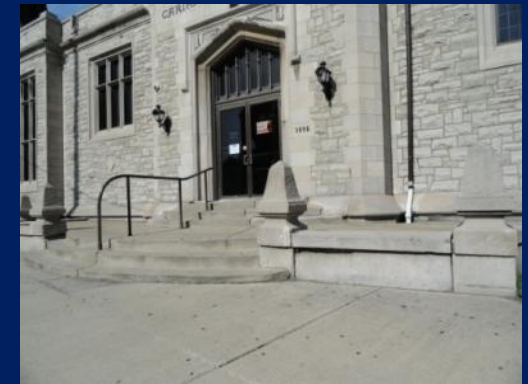
South Branch

Need ADA compliant parking spaces:

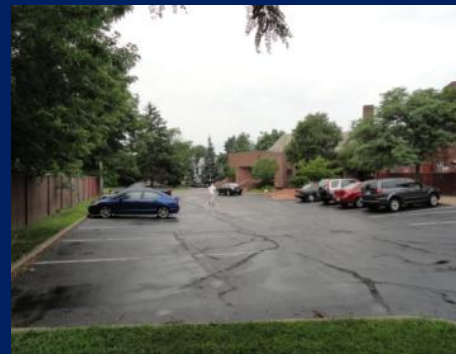
Need pavement repair

West Park Branch

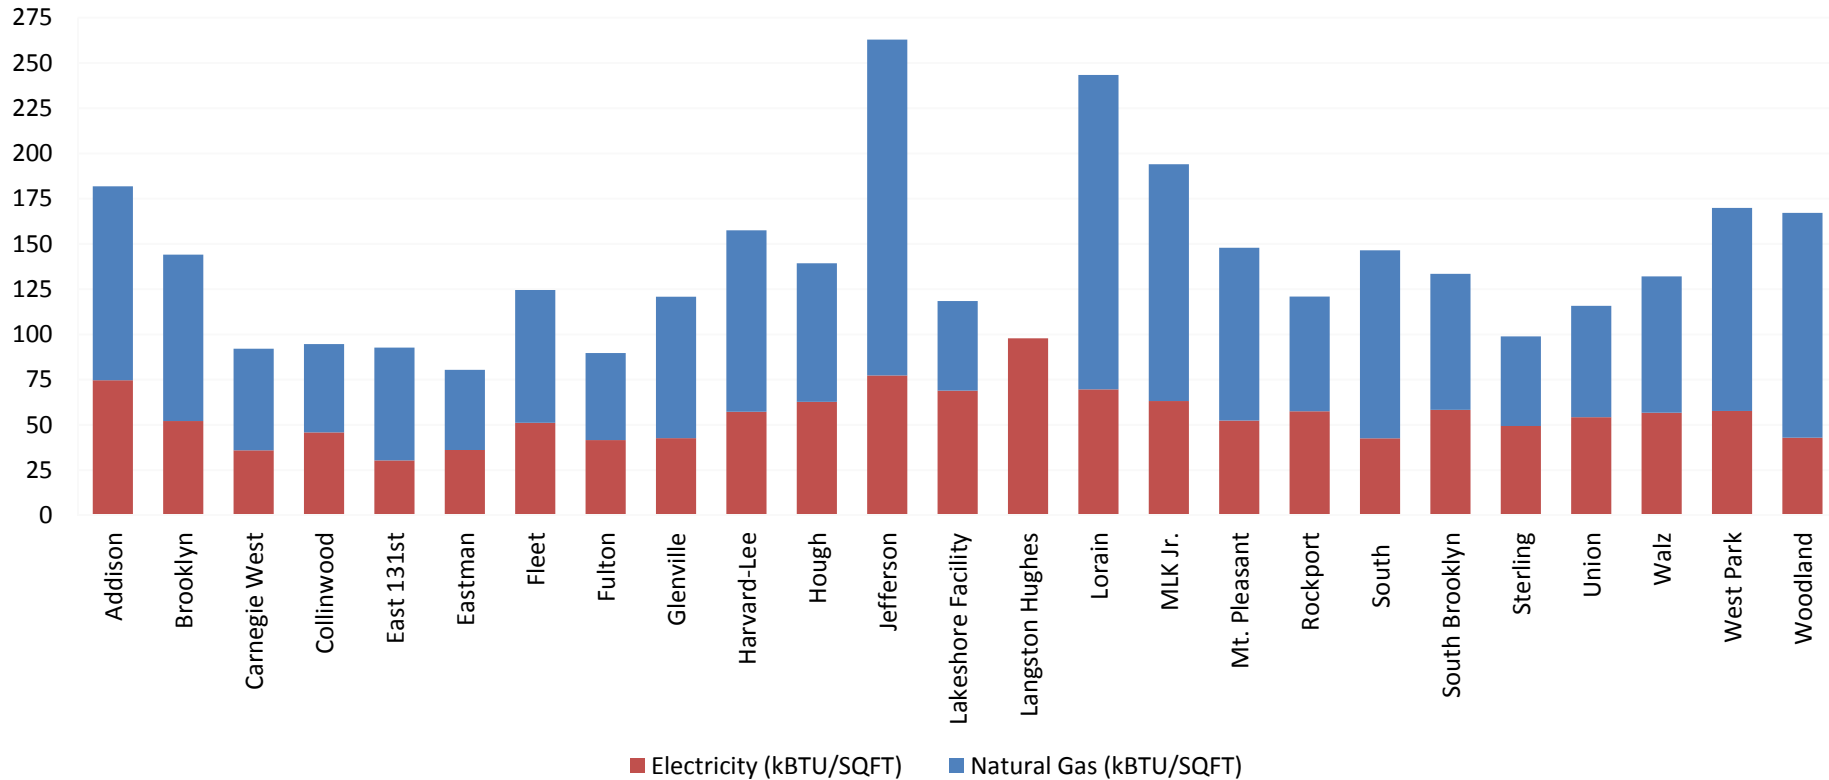
**Cleveland Public Library - Energy Use Comparison  
(kBTU/Yr/Occupied SQFT)**

\*Information based on actual utility bills provided by CPL.

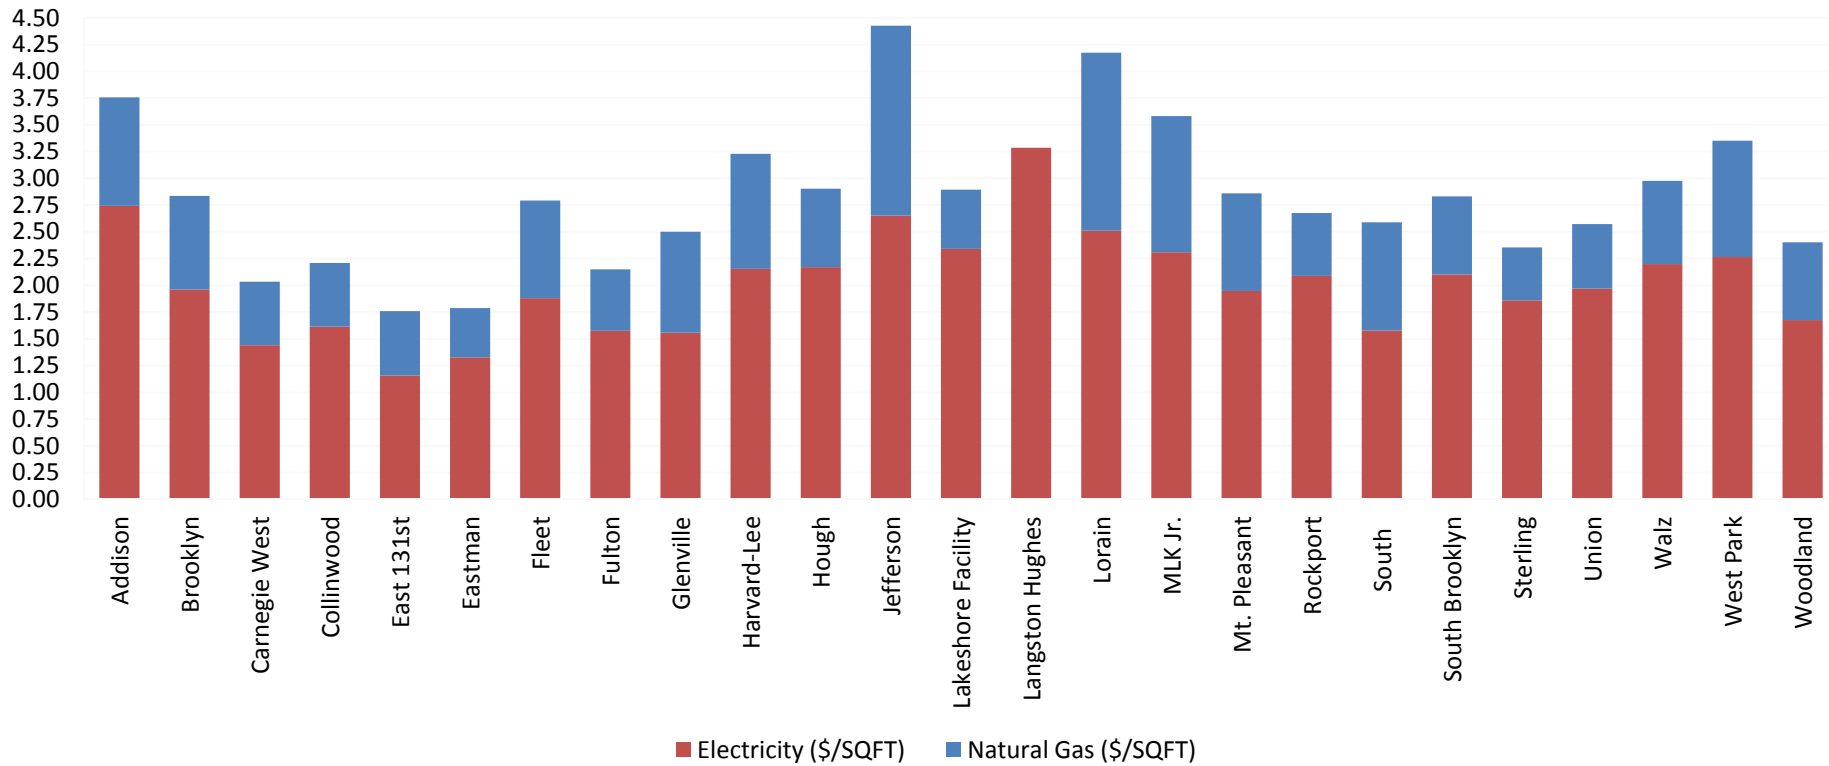
**Cleveland Public Library - Operating Cost Comparison  
(\$/Yr/Occupied SQFT)**

\*Information based on actual utility bills provided by CPL.

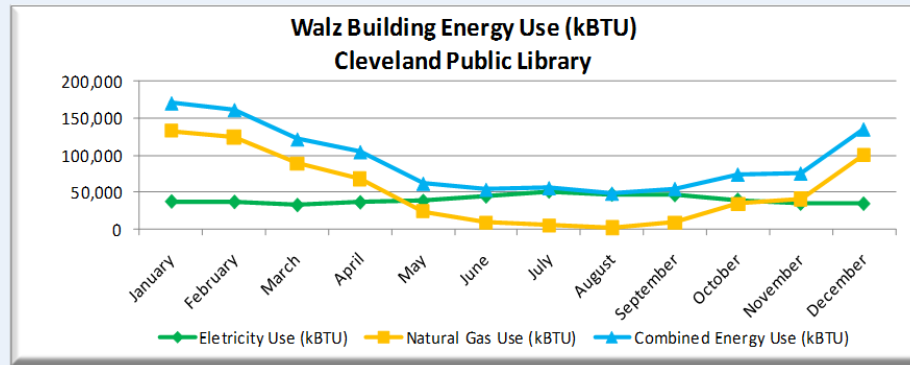
Building #23  
Walz Branch Library

\$/SQFT:	<b>2.98</b>	Goal: <\$2.0/SQFT
Overall kBTU/SQFT:	<b>132</b>	Goal: <92kBTU/SQFT
Gas kBTU/SQFT:	<b>75.4</b>	Goal: N/A
Electrical kWh/SQFT:	<b>16.61</b>	Goal: N/A

This library's large energy consumers consist of (2) 80% Efficient Boilers with a Constant Volume Forced Air Split System. Waltz's energy performance can be improved through engineered evaluation, the purchasing of high efficiency equipment, upgraded building and temperature controls, lighting upgrades, and building envelope improvements. The energy use curve of this branch appears to be normal with higher gas use in the winter time and higher electric use in the summer time.

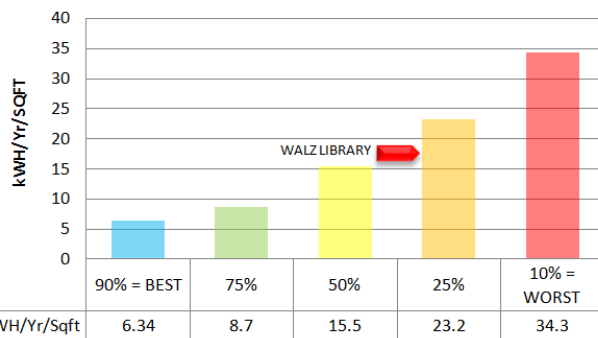
### National Electrical Energy Use Comparison For Libraries (kWh/Yr/SQFT)

Overall Energy Use (kBTU/SQFT):	<b>10th</b>
Electrical Use (kBTU/SQFT):	<b>25th</b>
